Pull off Adhesive Bond Strength Assessments of some Corrosion-Protective Bitumen Coatings on Low Carbon Steel Plates

¹*Guma, T.N., ¹Ishaya, D.D.

¹Department of Mechanical Engineering, Nigerian Defence Academy, Kaduna, Nigeria

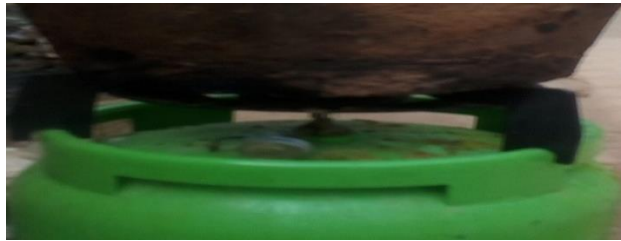
Plate 2. A bitumen sample as was being gas-heated in a steel container

OndoS.A, OndoS.B, and KPB bitumen samples were separately used to produce 75 coatings of more or less 5mm thickness between pair surfaces of the prepared plates. 15 fabricated similar mild steel molds with cavities of 65mm by 55mm cross sections by 25mm depths, were used for the coating. OndoS.A bitumen sample was gas-heated outdoor in a fairly big steel container to a thermometer-monitored temperature of about 155°C and ladled into a smaller steel container. The smaller container with its contents was put in the oven and the oven temperature adjusted to bitumen coating temperature of 150°C ±2 (Jakarmi, 2012). This was to ensure that all heated bitumen samples were at the same temperature of 150°C ±2 before coating. Before then, 15 prepared oven-kept plates were removed with steel tongs and separately placed in flat positions in the 15 mold cavities and grease applied to the cavities' surfaces to prevent or minimize bitumen sticking to the surfaces. The bitumen sample was then ladled from its container at its oven temperature and poured onto the prepared surfaces of the plates to the brims of the mold cavities. Matching male plates were then placed in position atop the poured bitumen and pressed slightly downwards by hand through suitable wooden slabs to make proper contact of the plates with the bitumen. The bonded plate assemblies were then removed from the molds with suitable steel tongs and placed in contact with ice blocks in a plastic bowl for 30minutes to allow the coatings set between the plates for better handling of the bonded assemblies. The bonded assemblies were removed from the bowl for further compression into the desired coating thickness. This was repeatedly carried out with the aid of 15 assistants until the required number of bonded assemblies was produced with each bitumen sample but in each case after cleaning off any attached bitumen to the mold cavities with kerosene and brush. Plate 1 shows one of the fabricated steel molds used for the coating, while Plates 2 and 3 show the bitumen heating facilities, and the front view of the oven respectively.

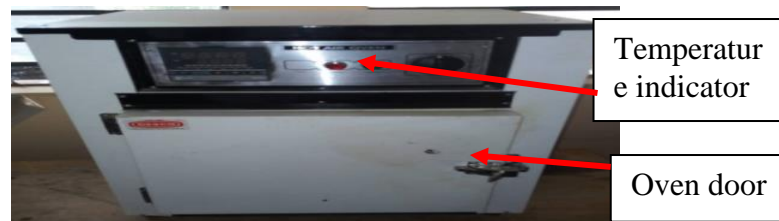
Plate 3. Front view of the oven used for heat-maintaining bitumen samples at $150^{\circ}\text{C} \pm 2$ in steel containers

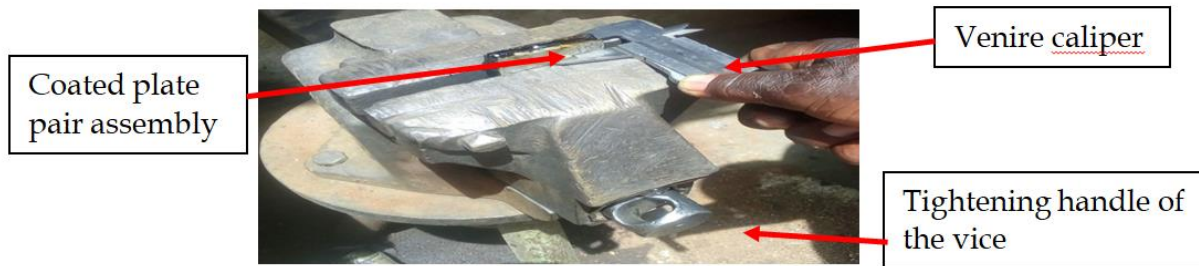
Plate 4. An instance of compressing plate pair assembly to achieve requisite coating thickness with a precision vice jaws and a micrometer

15 coatings of; 0.81mm, 0.93mm, 1.13mm, 1.29mm and 1.46mm-thickness were produced with each of OndoS.A, OndoS.B, and KPB bitumen samples. The coating thickness of 0.81mm was achieved by holding a given coat-bonded plate pair assembly between the jaws of a precision machine vice as shown in Plate 4 and gradually tightening the assembly by tightening the vice until the sum of hitherto measured average thickness of the uncoated plate pairs (39.9mm) and the required bitumen coating thickness of 0.81mm was 40.71mm. The 40.71mm perpendicular length across the bonded plate pair assembly was ensured by setting the jaws of an accurate Venire caliper across the assembly and slowly tightening the caliper jaws as shown in Plates IV through gradual tightening of the vice jaws until the micrometer reading was 40.71mm. Any bitumen that overflowed the edges of the assembly was trimmed off with a hot steel blade and wiped off by dipping a small bristle brush in kerosene and cleaning the edges. In that way, 15 coatings of 0.81mm thickness were achieved between 15 plate pairs with each bitumen sample. The whole procedure was repeated to achieve each of 0.93mm, 1.13mm, 1.29mm, and 1.46mm-thick coatings between the plate pairs but by ensuring that the micrometer readings across-the-bond assembly were 40.83mm, 41.03, 41.19, and 41.36mm for the respective thicknesses. Plate 5, for example, shows some plate pair assemblies with the 0.81mm-thick coating achieved between them by the process.

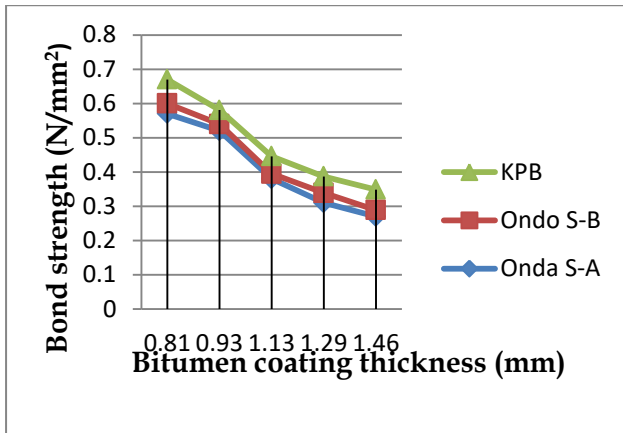
Fig 2. Effects of coating thickness variation on adhesive bond strength of coatings subjected to ambient condition of 23.8°C and 32.5% relative humidity for 12 hours

Figs. 2-6 show results of coating thickness variation and bond curing conditioning durations of 12 to 36 hours at average ambient laboratory environmental temperature of 23.8°C and relative humidity of 32.5% on adhesive bond

From **Figs. 2-6**, it is evident that the adhesive bond strengths of the coatings to the steel plates decrease gradually with increase in coating thickness. The bond strengths of the bitumen samples deviate minimally from one another for the same coating thickness and test conditions as can be observed from **Figs. 2-6**. However, the adhesive bond strengths of KPB coatings had an edge over those of OndoS.B, and those of OndoS.B over those of OndoS.A. Coatings of OndoS.A and OndoS.B exhibit closer comparative bond-strength performances with one another for the same coating thickness and test condition than those of KPB as can also be observed from **Figs.2-6**. From **Figs. 7-11**, it apparent that the bond strengths of the bitumen coatings to the steel plates increase appreciably with the conditioning time of the coatings up to 24 hours; and from there, no noticeable increase up to the 36-hour conditioning time. The overall highest bond strength of 0.978N/mm² was got from the 0.81mm-thick KPB coating conditioned from 24 to 36 hours. The bond strength decreased from this value with increase in coating thickness and decrease in conditioning time to least value of 0.27 N/mm² from the 1.46mm-thick OndoS.A coating that was

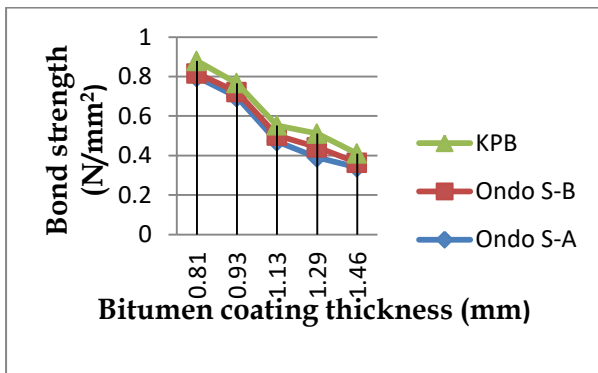
Fig 3. Effects of coating thickness variation on adhesive bond strength of coatings subjected to average ambient condition of 23.8°C and 32.5% relative humidity for 18 hours

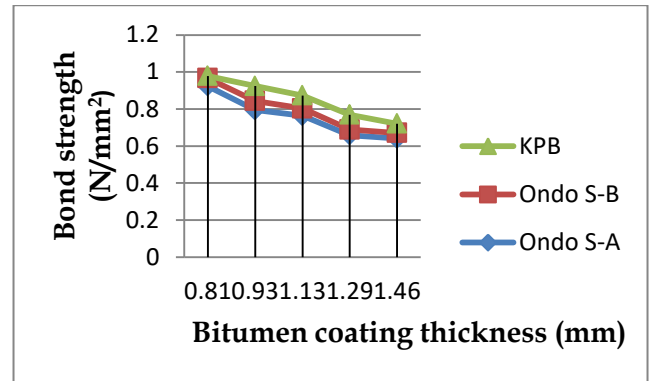
Fig 4. Effects of coating thickness variation on adhesive bond strength of coatings subjected to ambient condition of 23.8°C and 32.5% relative humidity for 24 hours

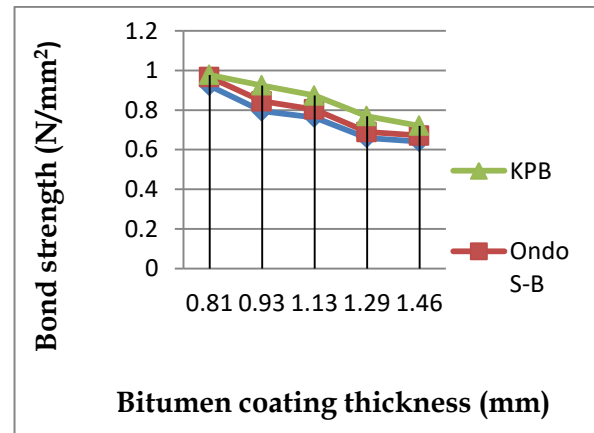
Fig. 5. Effects of coating thickness variation on adhesive bond strength of coatings subjected to ambient condition of 23.8°C and 32.5% relative humidity for 30 hours

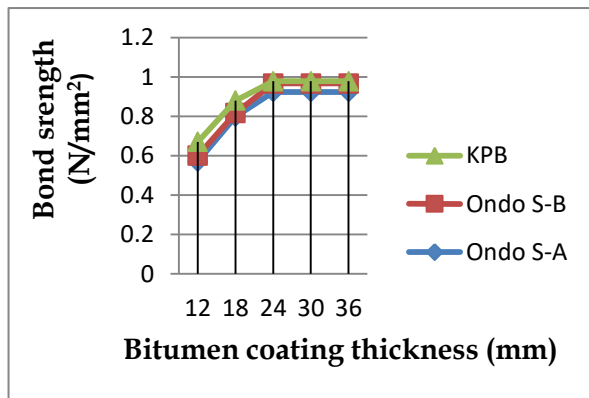
Fig 7. Effects of conditioning time at 23.8°C and 32.5% relative humidity ambient condition on the adhesive bond strength of the 0.81mm-thick bitumen coatings

strengths of; OndoS.A, Ondo S.B, and KPB bitumen coatings to the test low carbon steel. Figs. 7-11 on the other hand depict effects of variation of bond strength of the 0.81 to 1.46mm-thick bitumen sample coatings with the conditioning duration under the same ambient conditions. The evaluated mean bond strengths (\bar{S}_i), standard deviation (σ), and coefficients of variation (\bar{V}_i), of the 75 test-obtained data values of bond strengths (S_i) using Microsoft Excel statistical tools are shown in Tables 1 and 2. The determined pull off adhesive failure modes of the bitumen coatings for the various curing conditions is presented in Table 3 as adhesive (A), cohesive (C), and combined mode (AC).

conditioned for 12 hours as can be observed in [Figs. 7- 11](#). The differences in bond strengths of the bitumen coatings to the steel plates under the same conditions could be attributed to differences in the quality of bitumen from the samples' sources. This is because bitumen can exist naturally or be produced and supplied in various grades with appreciable differences in quality and service performances. Bitumen of different grades or qualities have been found to exhibit different levels of adhesion to a wide range of materials such as plastics, metals, and aggregates ([Baglin, 1988](#); [Jakarmi, 2012](#)).

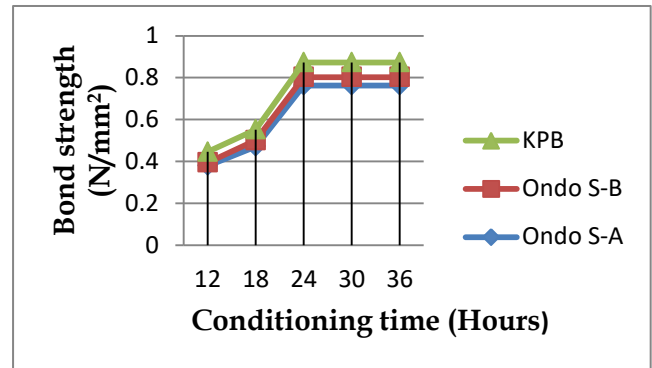
Fig 9. Effects of conditioning time at 23.8°C and 32.5% relative humidity ambient condition on the adhesive bond strength of 1.13mm-thick bitumen coating

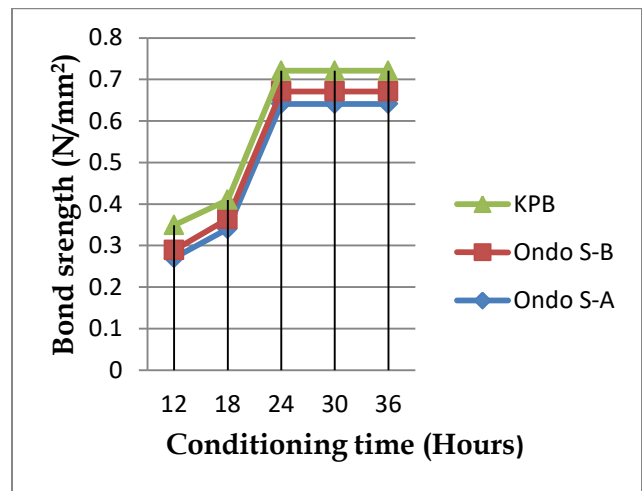
Fig 10. Effects of conditioning time at 25°C and 35% relative humidity ambient condition on the adhesive bond strength of the 1.29mm-thick bitumen coating

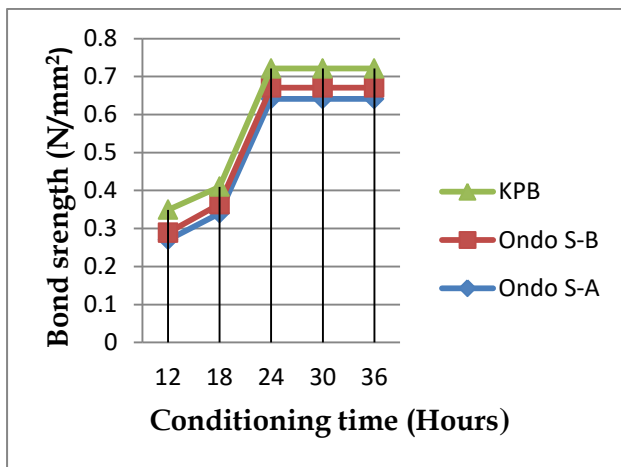
Fig 11. Effects of conditioning time at 25°C and 35% relative humidity ambient condition on the adhesive bond strength of the 1.46mm-thick bitumen coatings
